The Fire Resistance Performance of a Loadbearing Timber Floor Assembly Protected by a Plasterboard Ceiling Designed to Provide 30 minutes Fire Resistance, Incorporating Twenty Three Downlight Fittings, When Tested Accordance with BS EN 1365 - 2: 2014

**WF Report No: 385023-B**

**Integral LED**

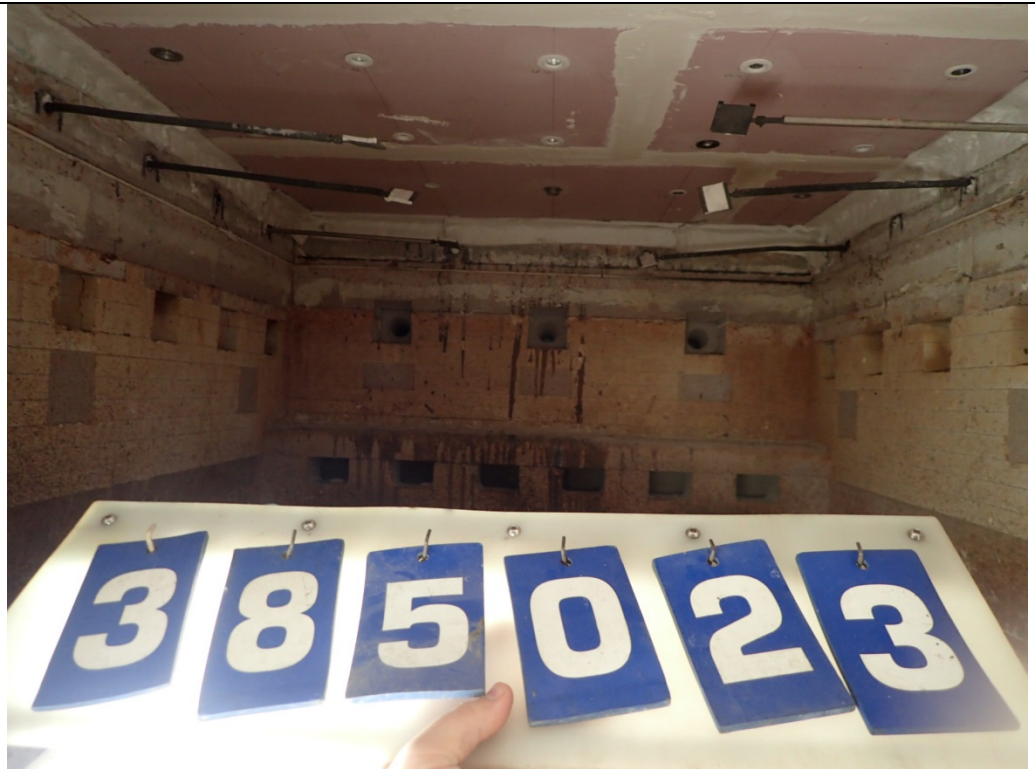
The exposed face of the assembly prior to the start of the test

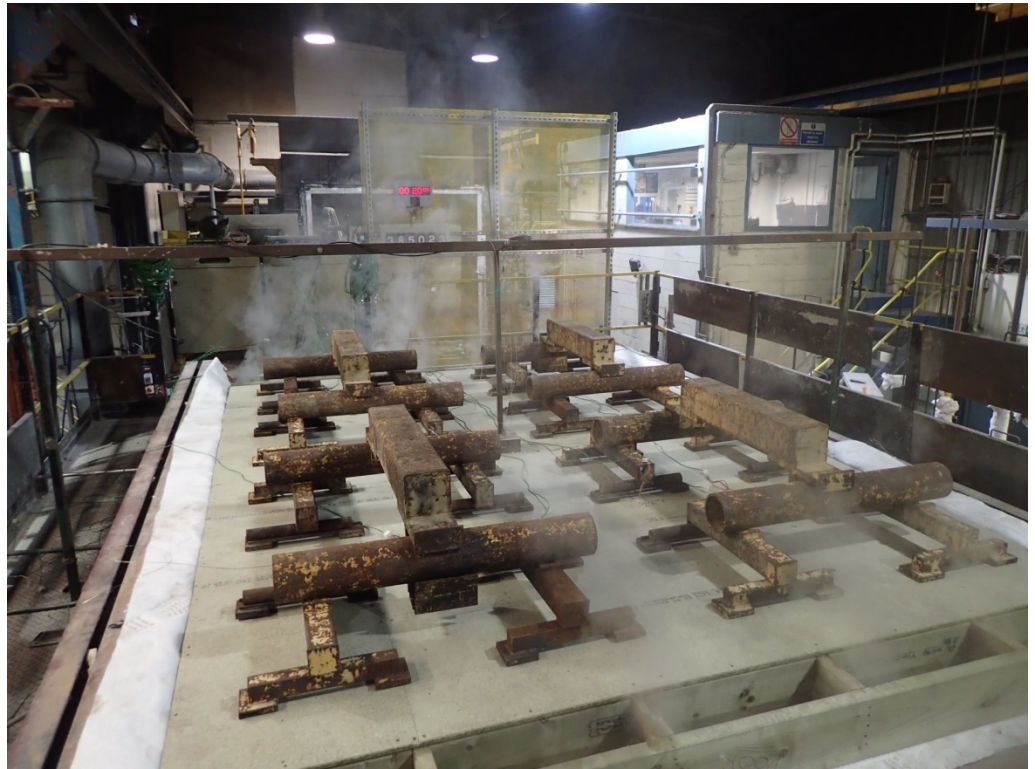
The unexposed face of the assembly after 20 minutes of testing

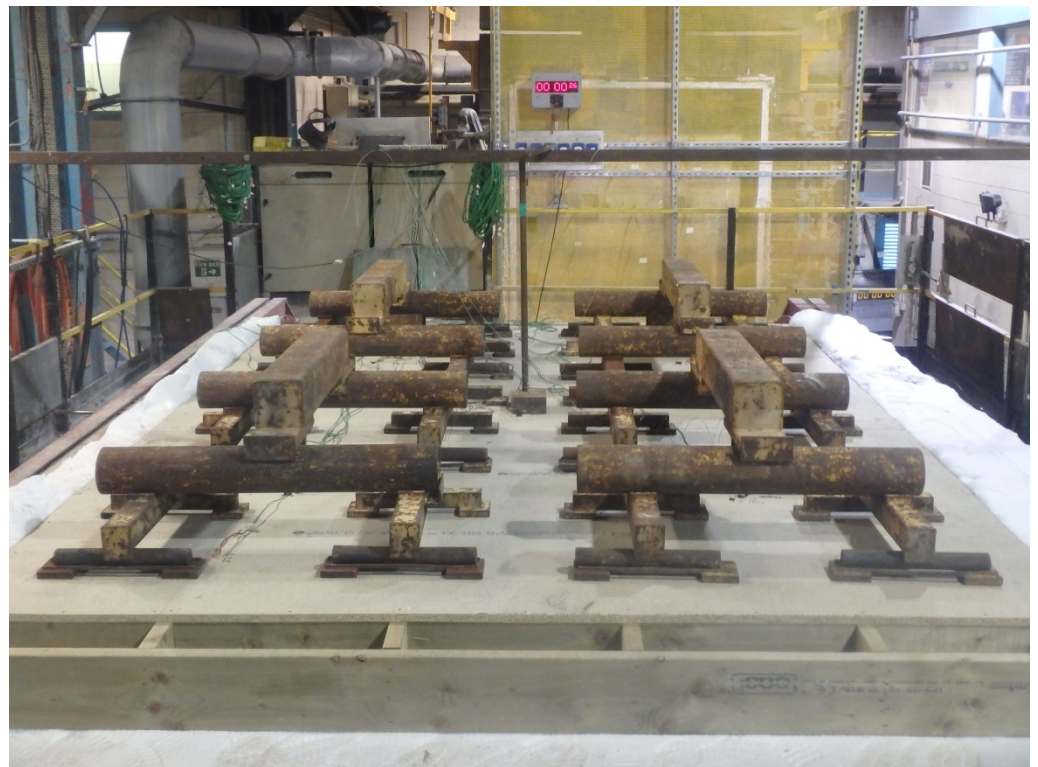
The unexposed face of the assembly prior to the start of the test

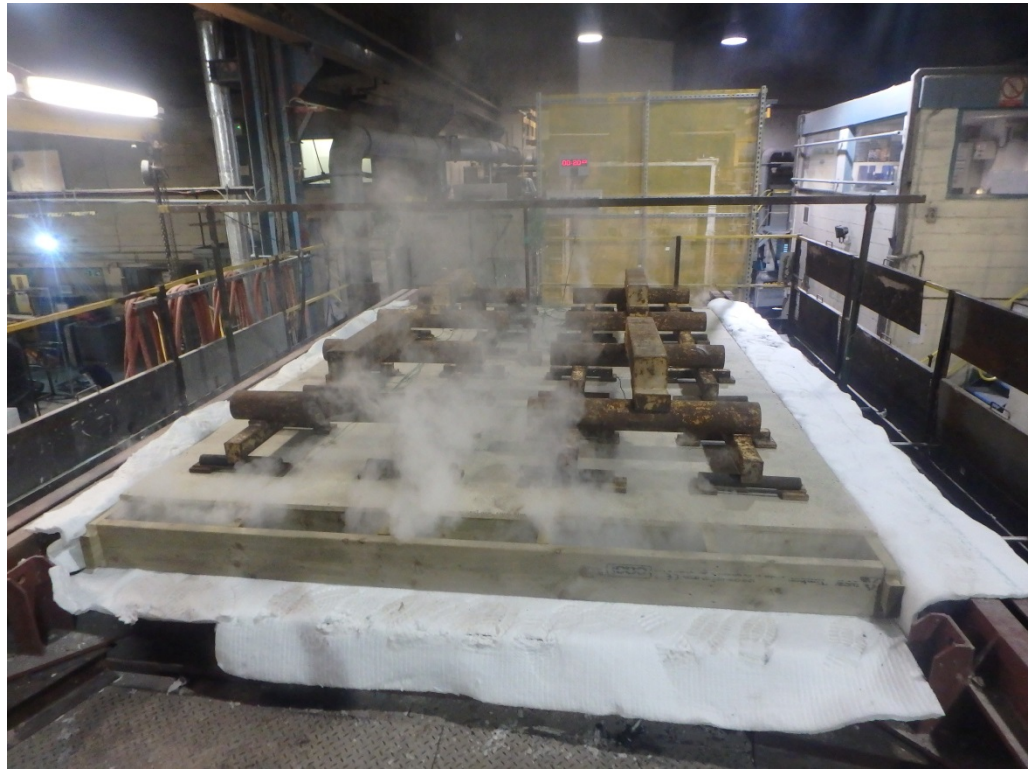
The unexposed face of the assembly after 20 minutes of testing

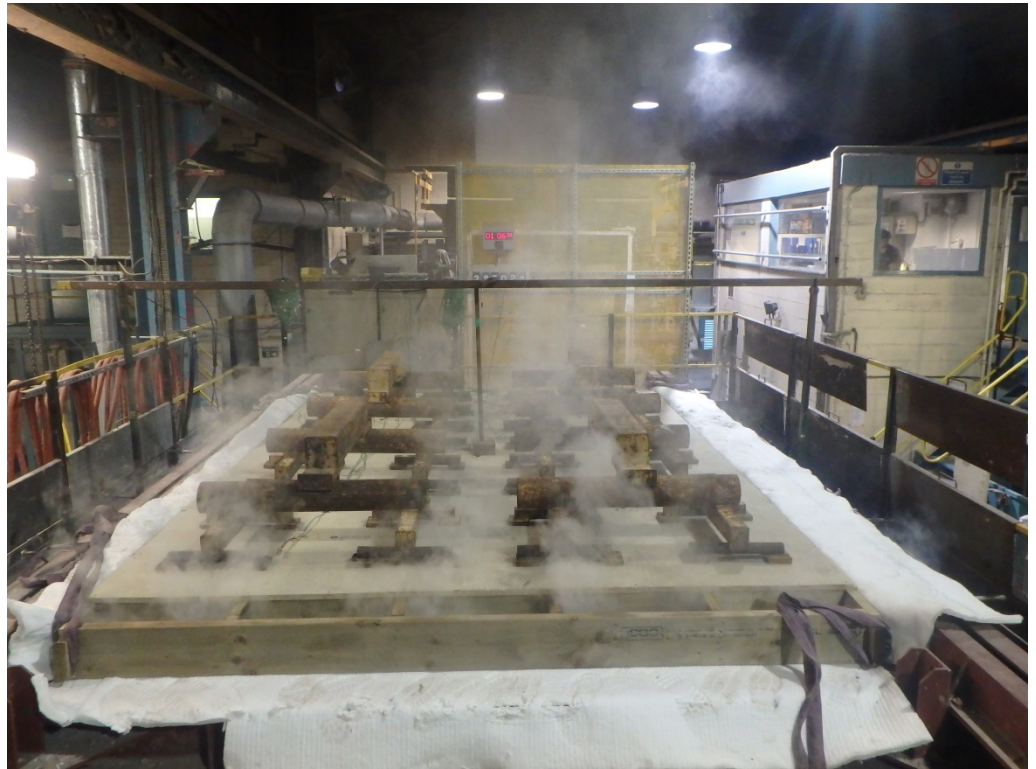
The unexposed surface of the assembly after a test duration of 66 minutes

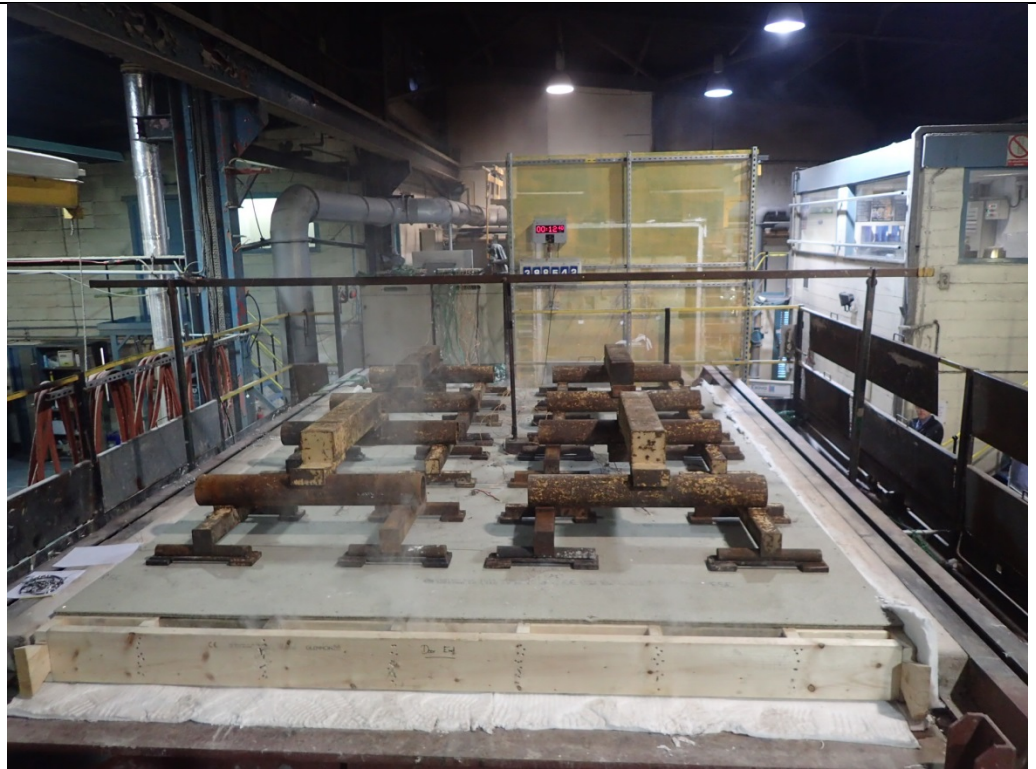
The unexposed face for the assembly after a test duration of 12 minutes

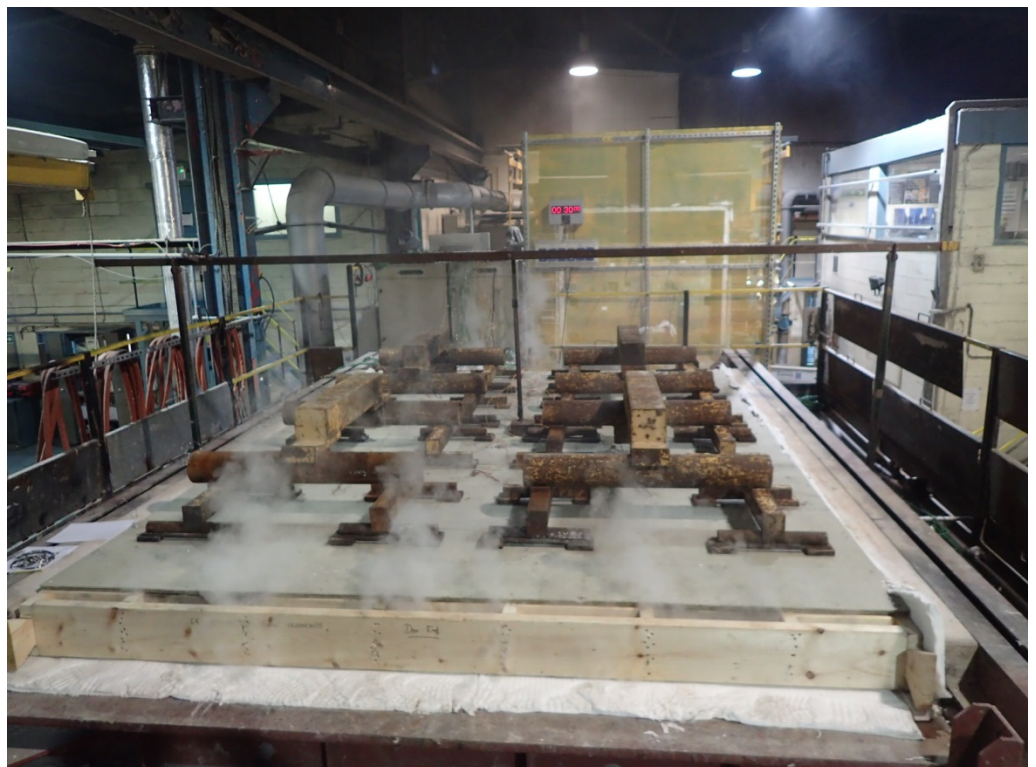
The unexposed face of the assembly after 30 minutes of testing
