The Fire Resistance Performance of a Loadbearing Timber Floor Assembly Protected by a Plasterboard Ceiling Designed to Provide 30 minutes Fire Resistance, Incorporating Twenty Three Downlight Fittings, When Tested Accordance with BS EN 1365 - 2: 2014

WF Report No: 385023-B

Integral LED

388542A Issue 2

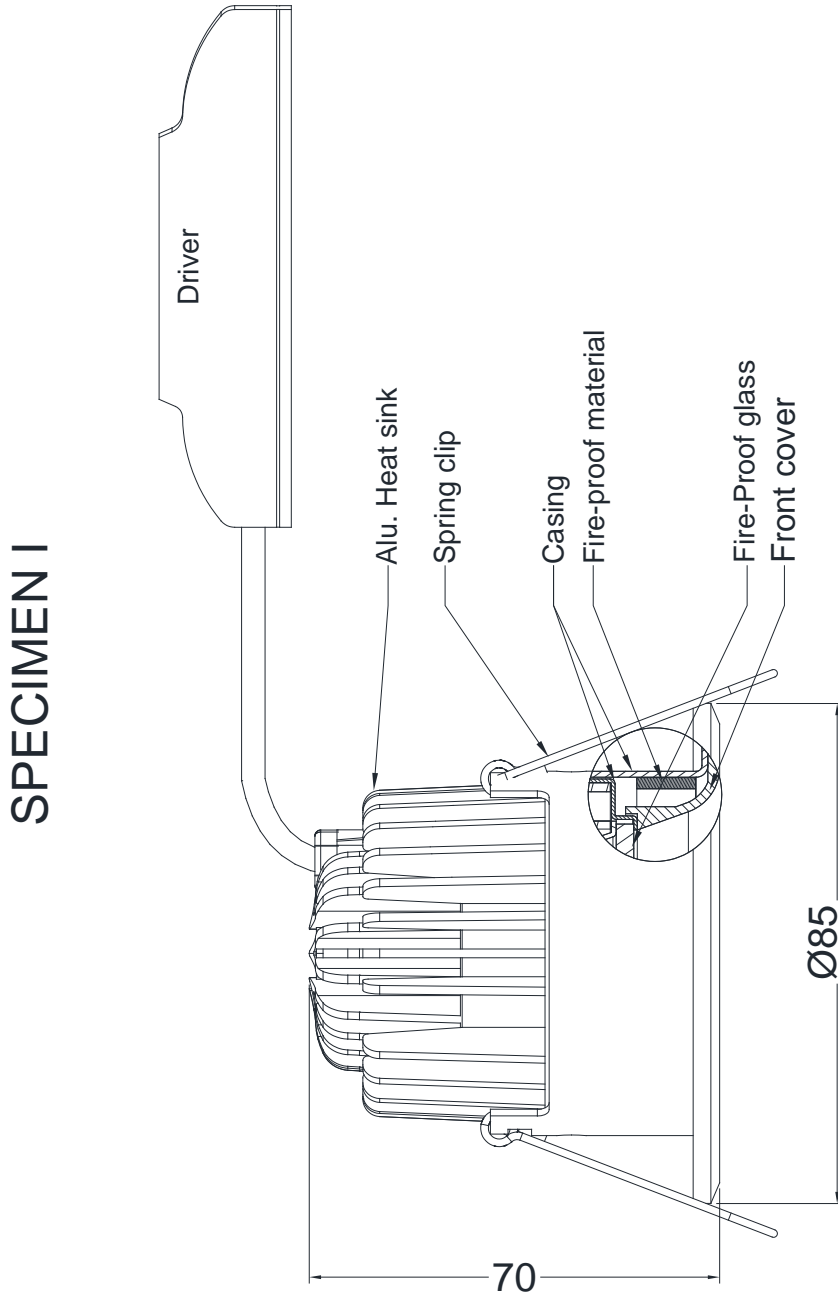
Figure 3 – Details of Downlighters Specimen I

SPECIMEN I

Fixed
With reflector ILDLFR70AXXX
Cut out: Ø70

10. Specimen I	
Manufacturer	: Integral LED
Type	: Round, fixed, LED recessed downlight
Reference	: ILDLFR70AXXX
Materials	
i. casing	: Mild steel
ii. front cover	: Die cast aluminium
iii. heat sink	: Die cast aluminium
iv. spring clip	: Stainless steel

v. gasket	: 4.3 mm wide x 1.7 mm thick flexible plastics ring
Overall dimensions and construction	: See Figure 11 for details
Cut out size	: 70 mm diameter
Driver	: None
Lamp	: COB

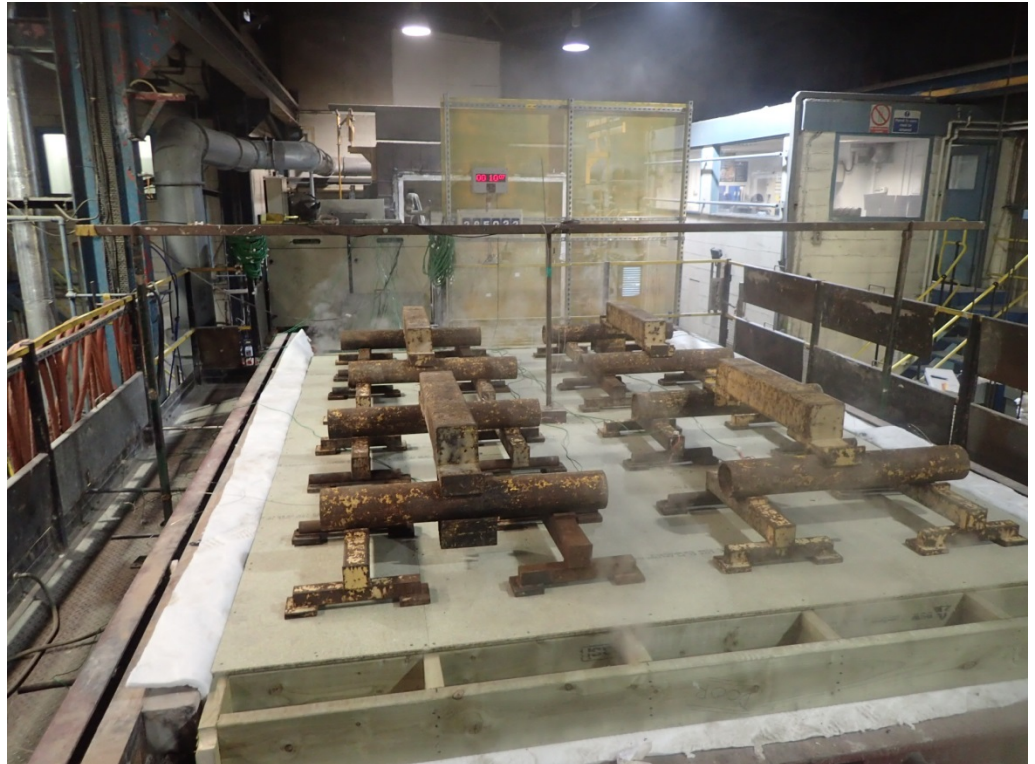
The unexposed face of the assembly after 10 minutes of testing

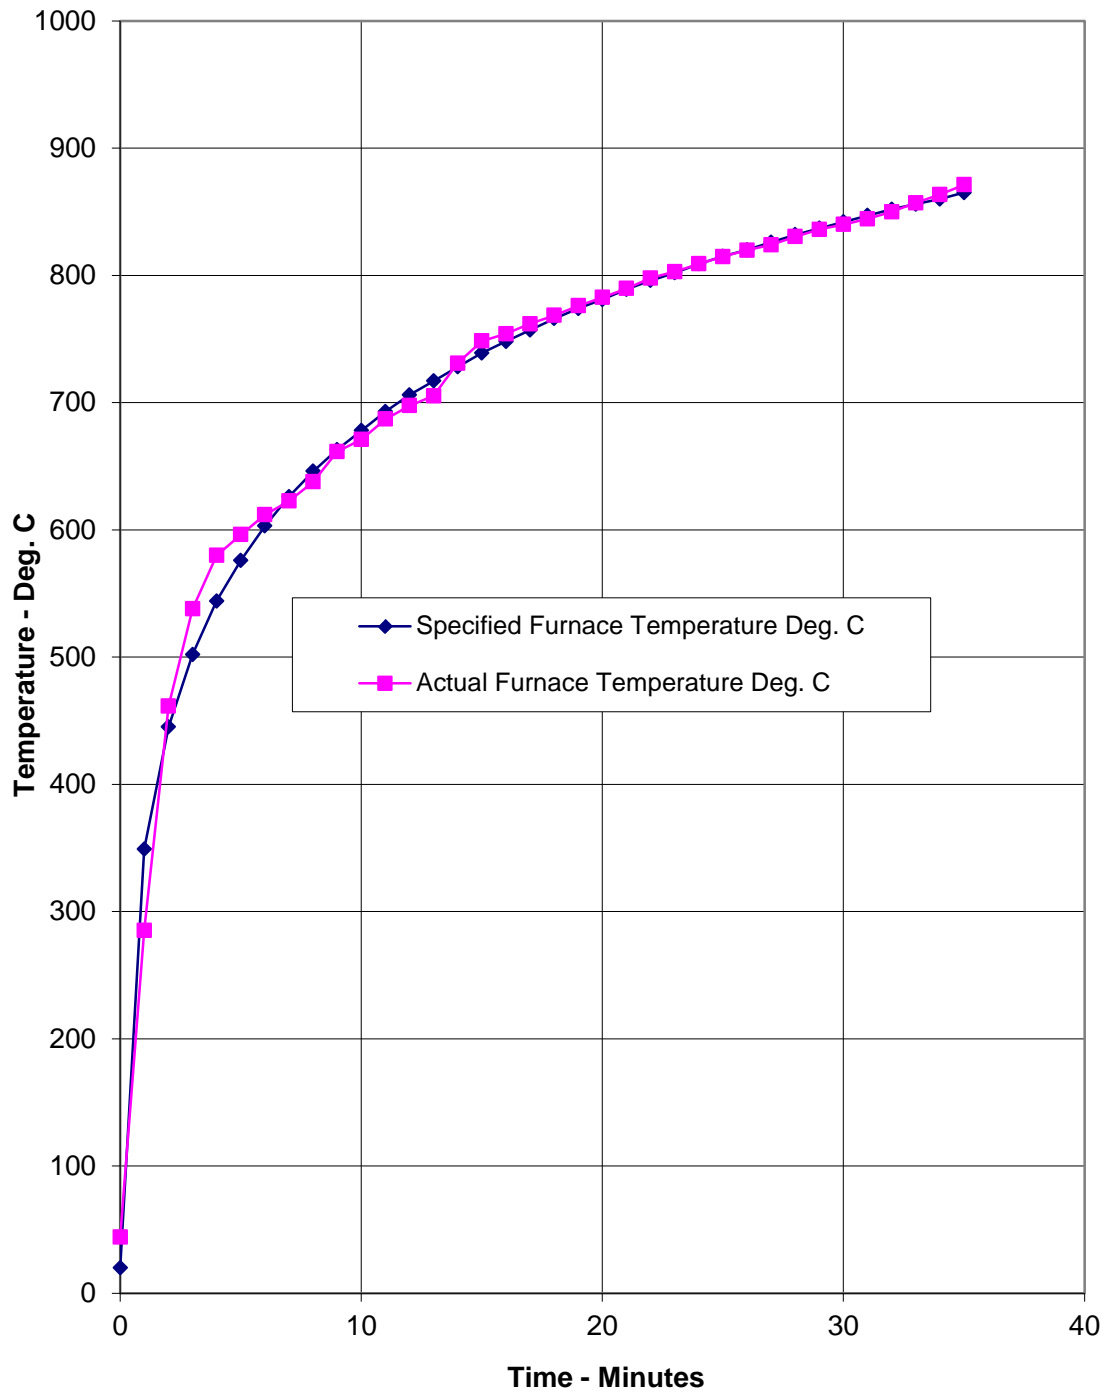
Graph showing specified and actual furnace temperatures

Time Mins	Specified Furnace Temperature Deg. C	Actual Furnace Temperature Deg. C
0	20	44
1	349	285
2	445	461
3	502	538
4	544	580
5	576	596
6	603	612
7	626	623
8	646	638
9	663	662
10	678	671
11	693	687
12	706	698
13	717	705
14	728	731
15	739	748
16	748	754
17	757	762
18	766	769
19	774	776
20	781	783
21	789	790
22	796	798
23	802	803
24	809	809
25	815	815
26	820	820
27	826	824
28	832	831
29	837	836
30	842	840
31	847	844
32	852	850
33	856	857
34	860	864
35	865	871

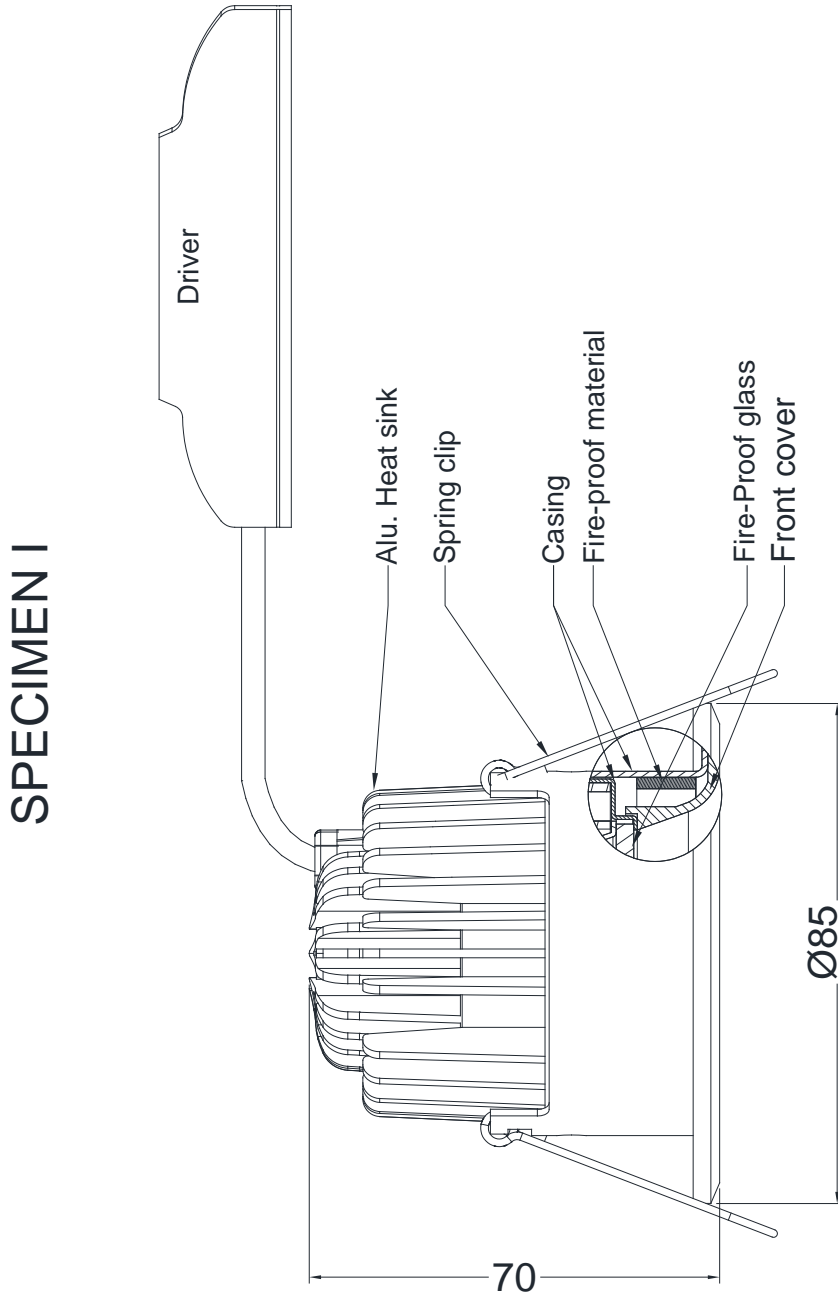
Figure 3 – Details of Downlighters Specimen I

SPECIMEN I

Fixed
With reflector ILDLFR70AXXX
Cut out: Ø70

10. Specimen I	
Manufacturer	: Integral LED
Type	: Round, fixed, LED recessed downlight
Reference	: ILDLFR70AXXX
Materials	
i. casing	: Mild steel
ii. front cover	: Die cast aluminium
iii. heat sink	: Die cast aluminium
iv. spring clip	: Stainless steel

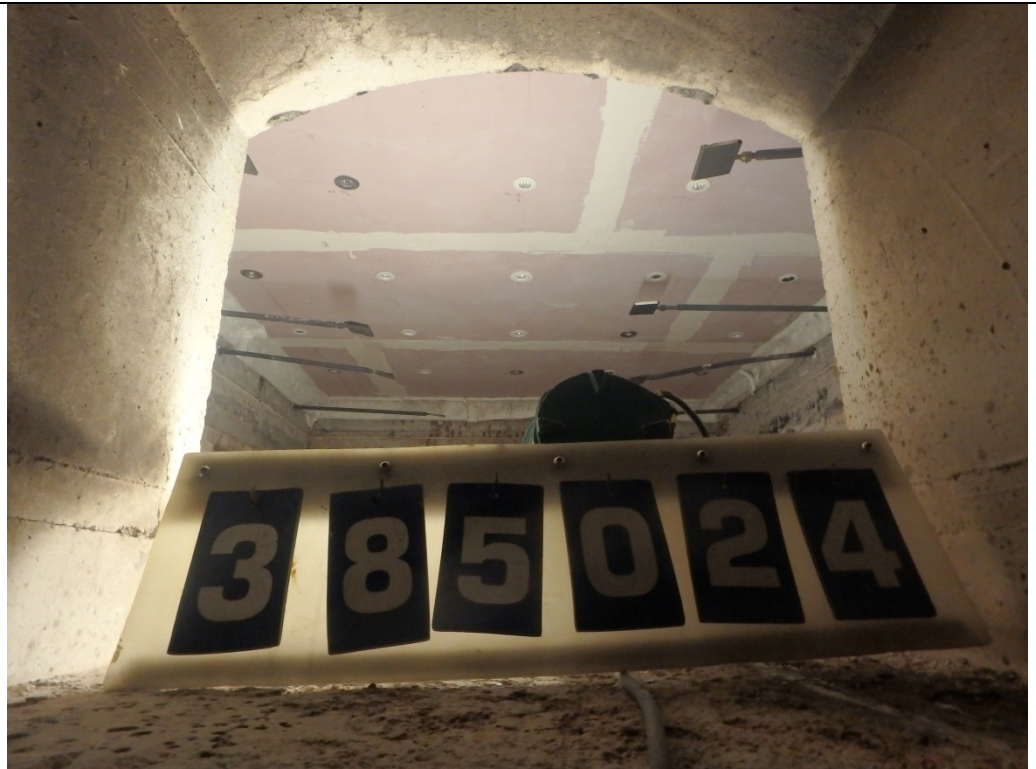
The exposed face of the assembly prior to the start of the test

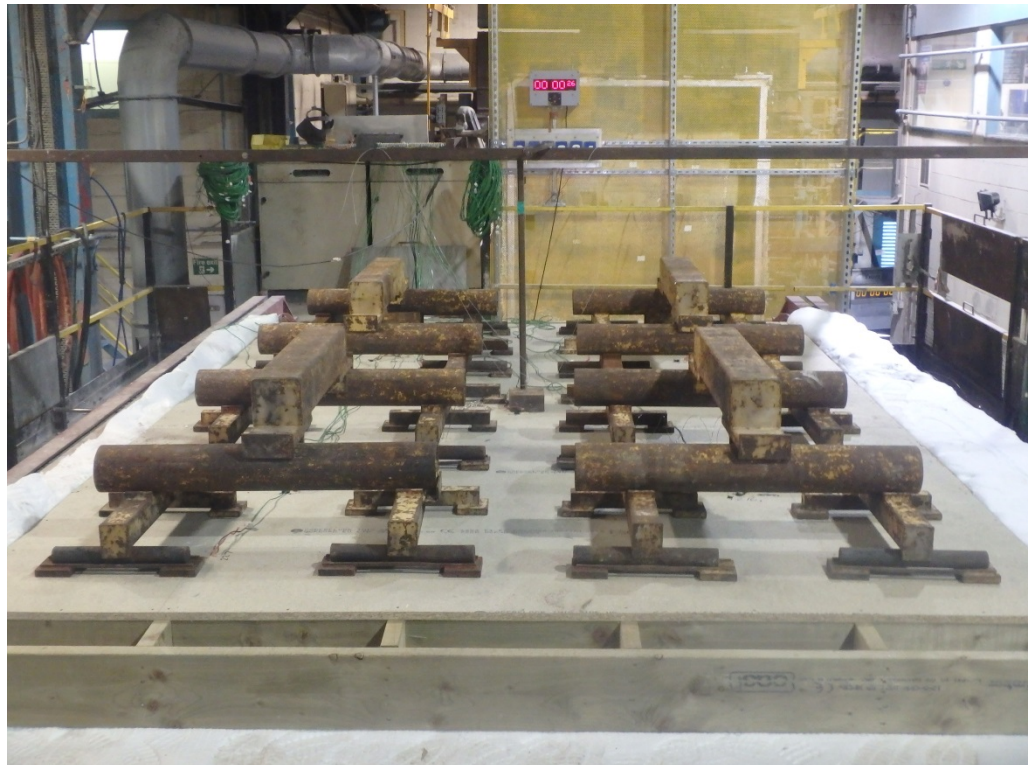
The unexposed face of the assembly prior to the start of the test

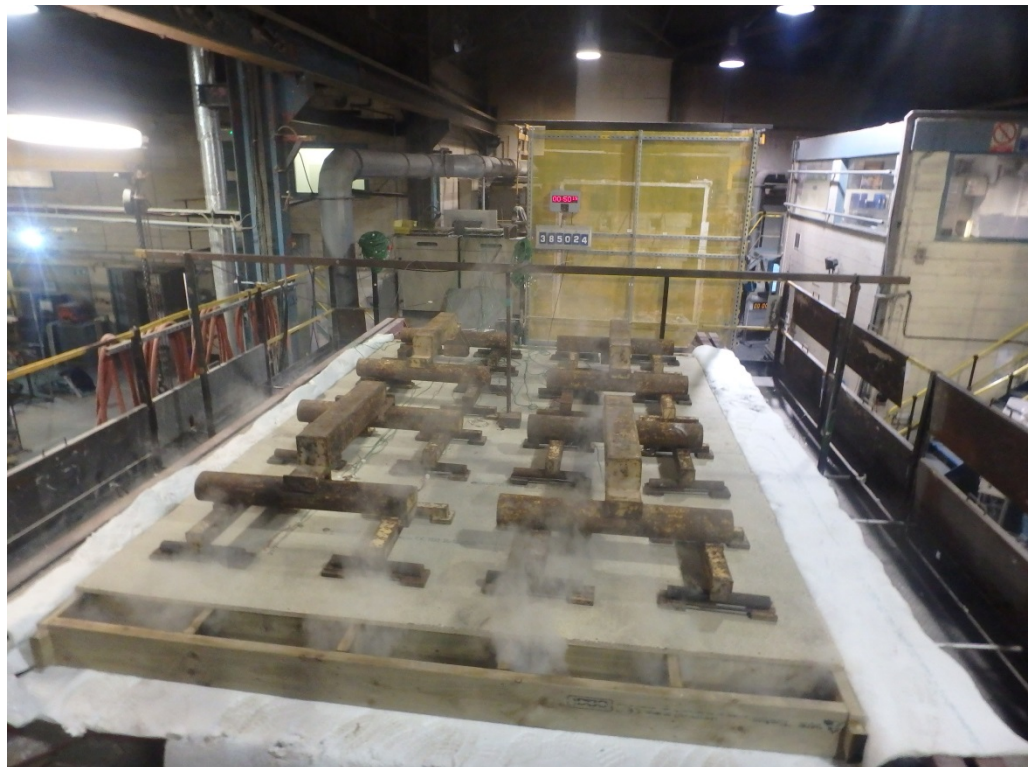
The unexposed surface of the assembly after a test duration of 50 minutes

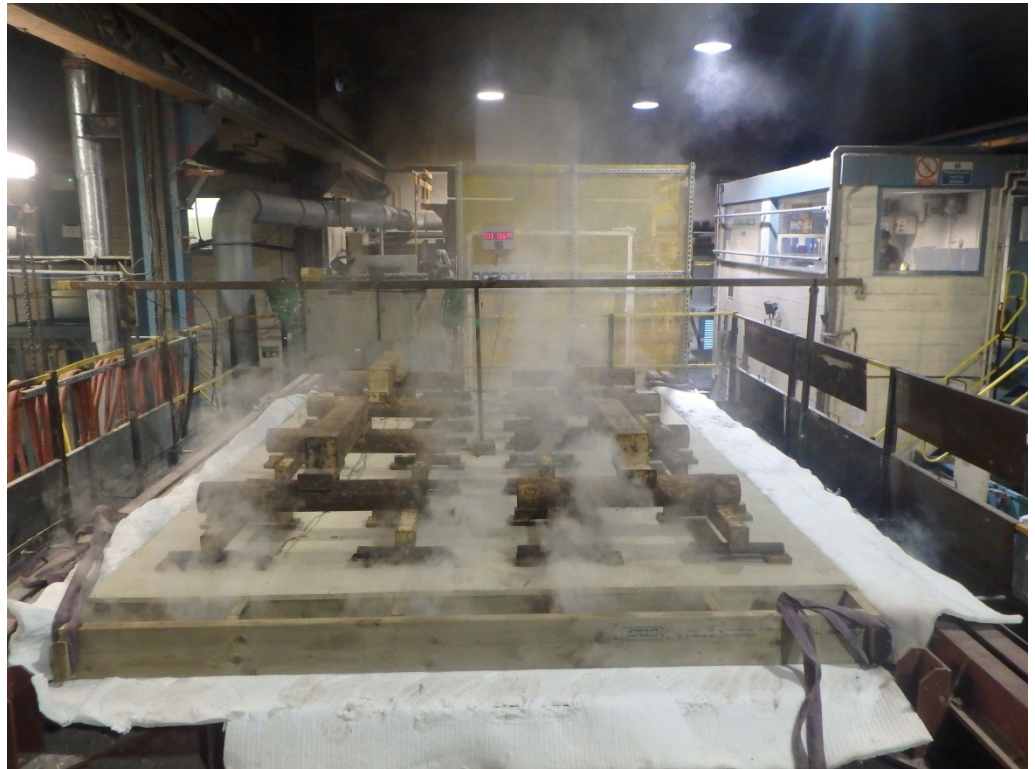
The unexposed surface of the assembly after a test duration of 66 minutes

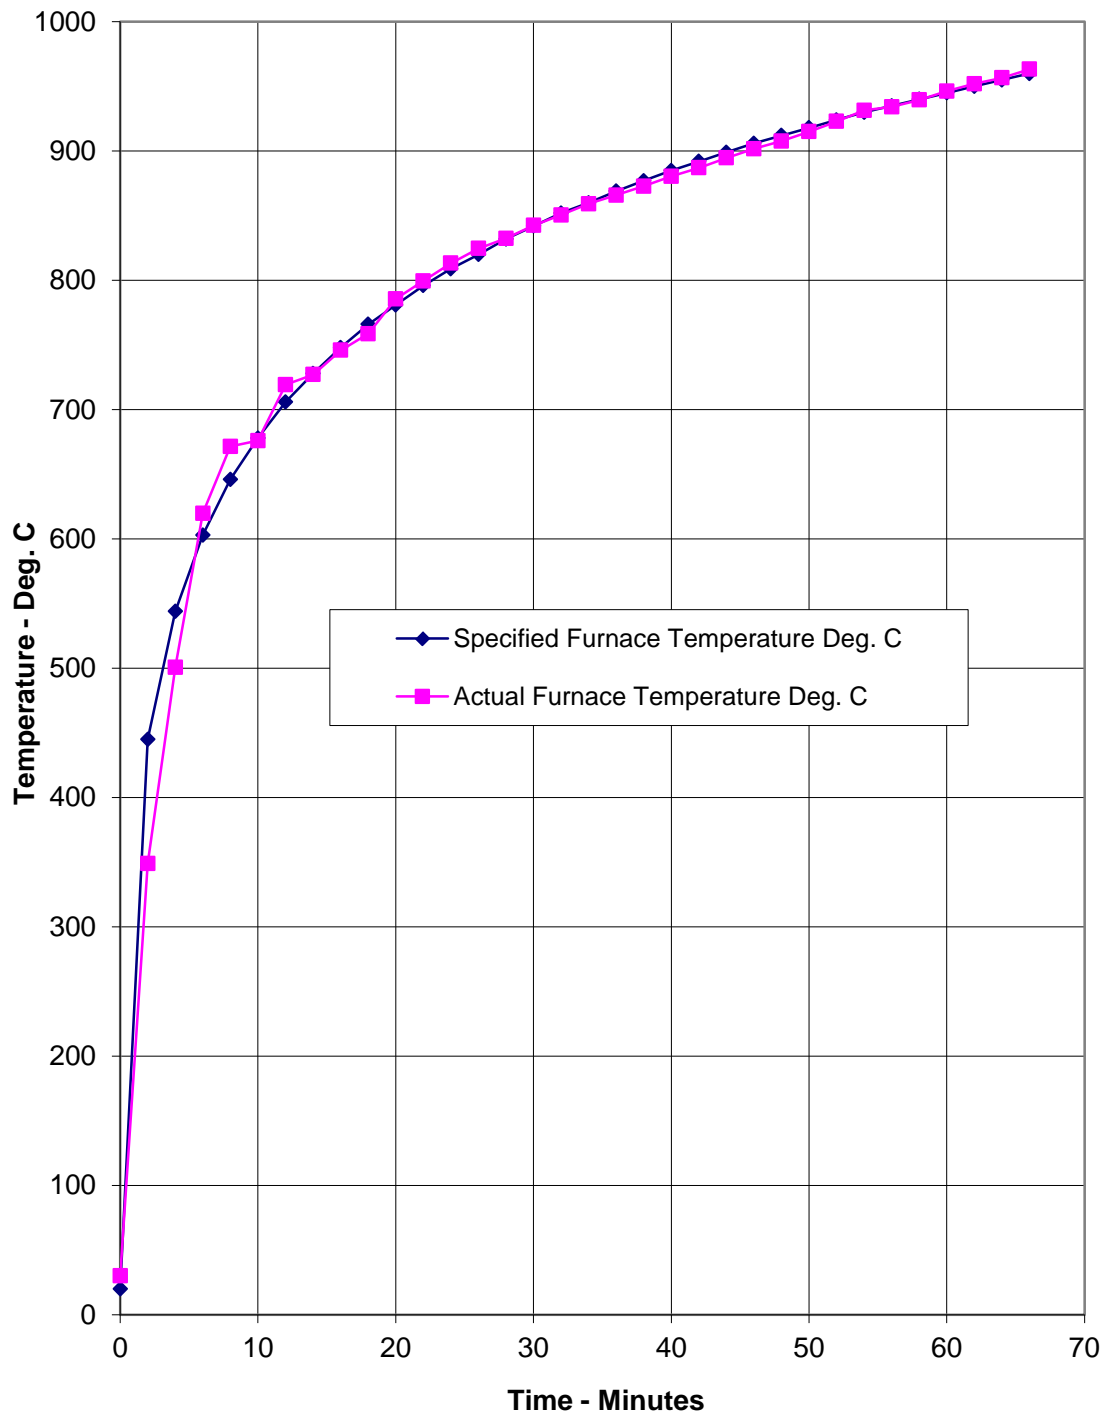
Graph showing specified and actual furnace temperatures

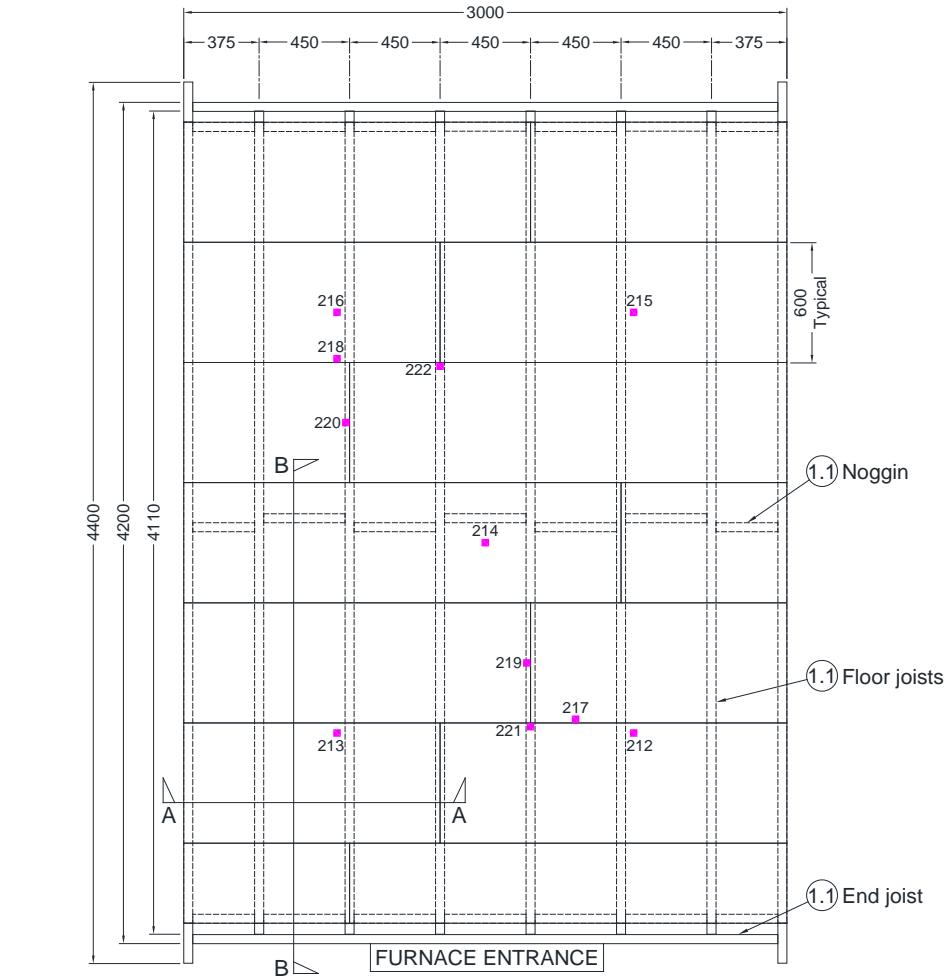
Figure 1- General Elevation of Test Construction

Key
 ■ Surface thermocouple
 PLAN OF THERMOCOUPLE POSITIONS

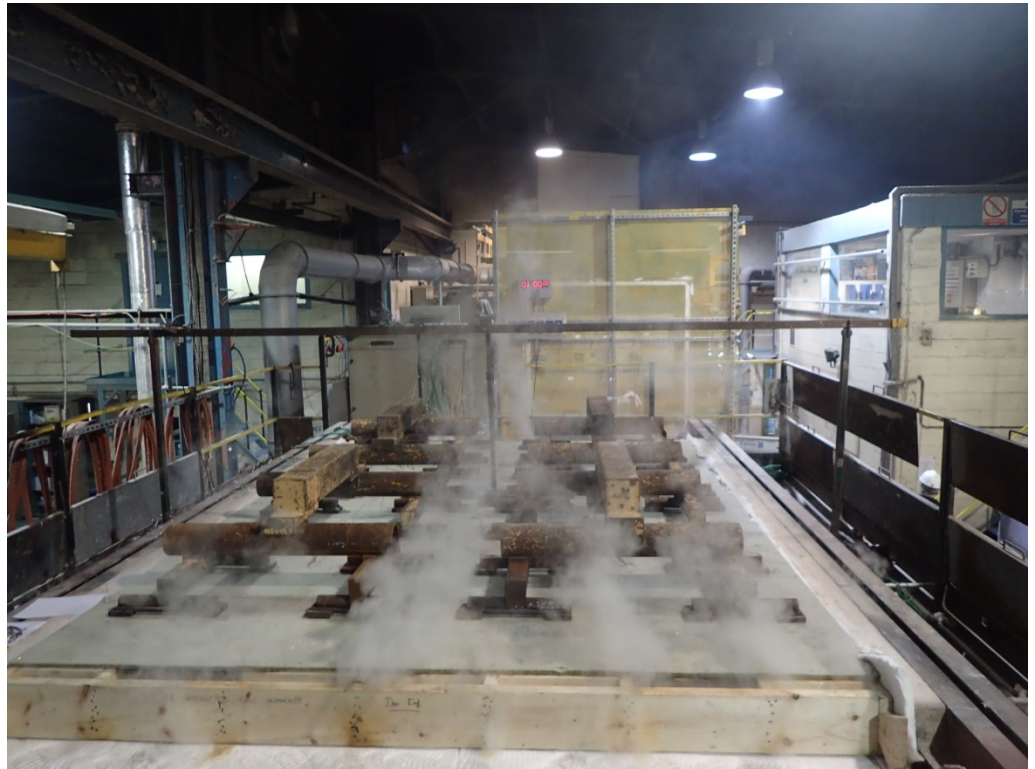
The unexposed face of the assembly after a test duration of approximately 60 minutes

Time		All observations are from the unexposed face unless noted otherwise.
mins	secs	The ambient air temperature in the vicinity of the test construction was 19°C at the start of the test with a maximum variation of +2°C during the test.
00	00	The test commences.
12	34	Small amount of smoke issue from both ends of the floor.
15	43	Viewed from exposed face: Jointing tape detached from all joints in the plasterboard.
20	45	Viewed from exposed face: Bezels from downlighters I and D detached.
23	23	Temperature above downlighter A reaches 200°C.
26	17	Viewed from exposed face: Downlighter J detaches.
30	00	No significant visible change to unexposed face.
60	00	No significant visible change to unexposed face.
60	50	Viewed from exposed face: All joints in first layer of plasterboard widened to approximately 3mm.
62	45	Viewed from exposed face: Joint in first layer of plasterboard at approximately mid-length of the assembly widened to approximately 5mm.

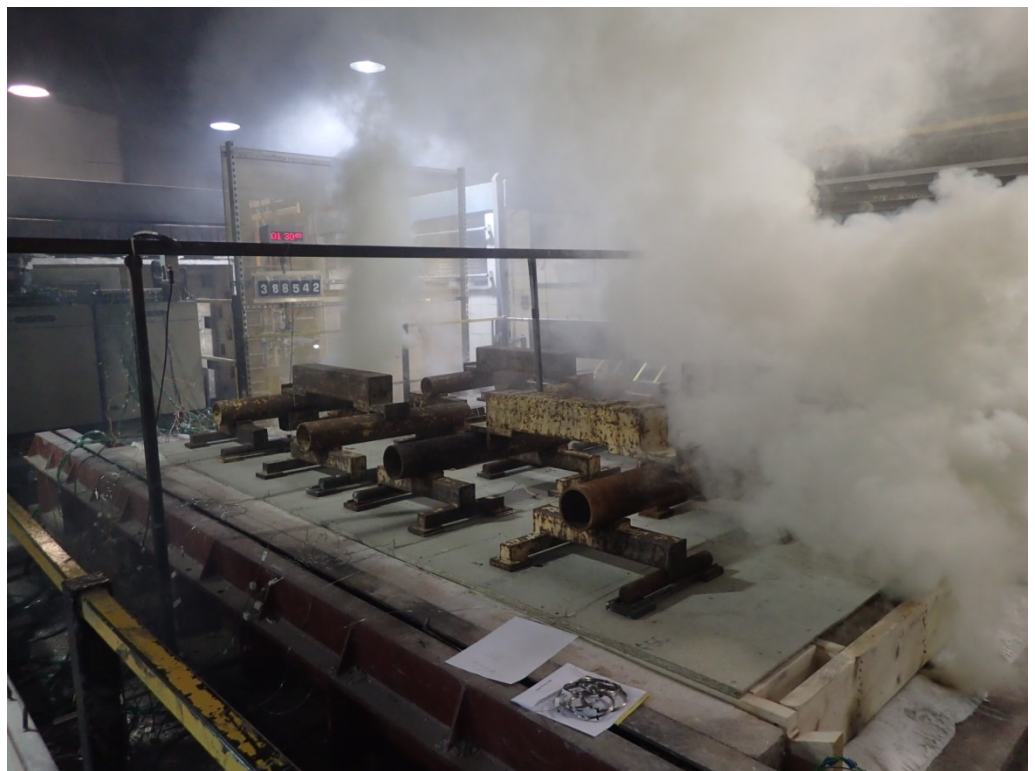
The unexposed face of the assembly after 90 minutes of testing
