The Fire Resistance Performance of a Loadbearing Timber Floor Assembly Protected by a Plasterboard Ceiling Designed to Provide 30 minutes Fire Resistance, Incorporating Twenty Three Downlight Fittings, When Tested Accordance with BS EN 1365 - 2: 2014

WF Report No: 385023-B

Integral LED

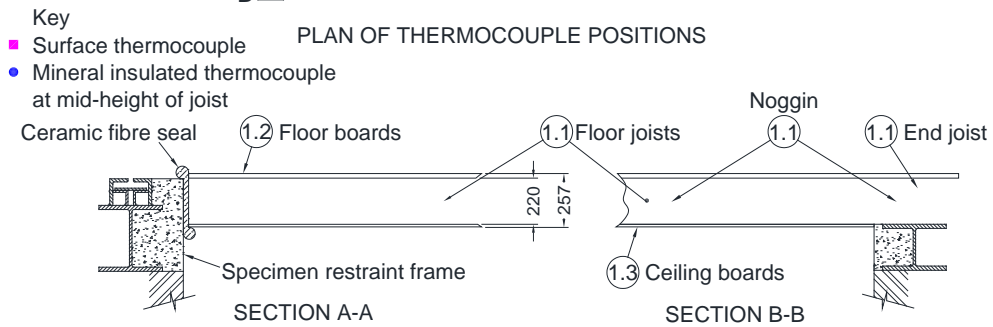
Figure 1- General Elevation of Test Specimen

Summary of Tested Assembly Briefly, the timber floor had overall nominal dimensions of 4500 mm long by 3000 mm wide and comprised softwood timber joists at 600 mm centres. The upper surface of the floor comprised nominally 22 mm thick tongue and grooved chipboard flooring.

The floor assembly was protected on its underside by a direct fixed ceiling, formed from a single layer of 12.5 mm thick British Gypsum Fireline plasterboard, the ceiling was screw fixed to the underside of the floor joists.

General	The instrumentation was provided in accordance with the requirements of the Standard.
Furnace	The furnace was controlled so that its mean temperature complied with the requirements of BS EN 1363-1: 2012, using eight plate thermometers distributed over a plane 100 mm from the underside of the test construction.
Thermocouple Allocation	Thermocouples were provided to monitor the unexposed surface of the floor assembly and the output of all instrumentation was recorded at no less than one minute intervals as follows:
Thermocouples 212 to 216	At five positions on the unexposed surface of the floor assembly, one approximately at the centre and one at approximately the centre of each quarter section.
Thermocouples 217 to 220 & 226 to 227	At six positions on the unexposed surface of the floor assembly, positioned adjacent to joints in the floor boarding.
Thermocouples 221 to 225	<p>At five positions in the air cavity of the floor assembly, one approximately at the centre and one at approximately the centre of each quarter section.</p> <p>The locations and reference numbers of the various unexposed surface and internal thermocouples are shown in Figure 1.</p>

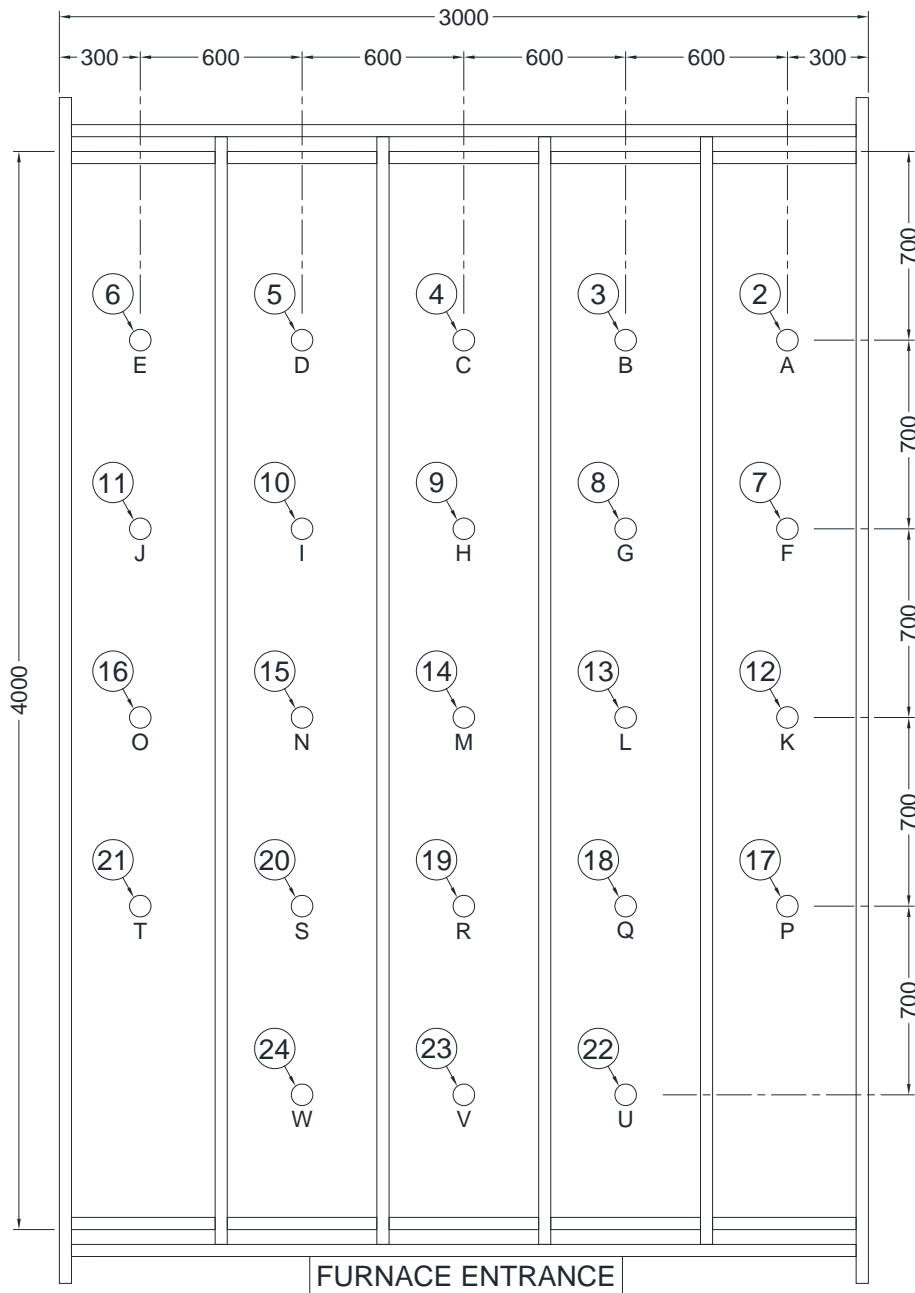
Figure 2 – Details of Downlighter Positions

The ceiling incorporated 22 down lighter light fittings, 2 of which are subject to this test report and were referenced as follows:

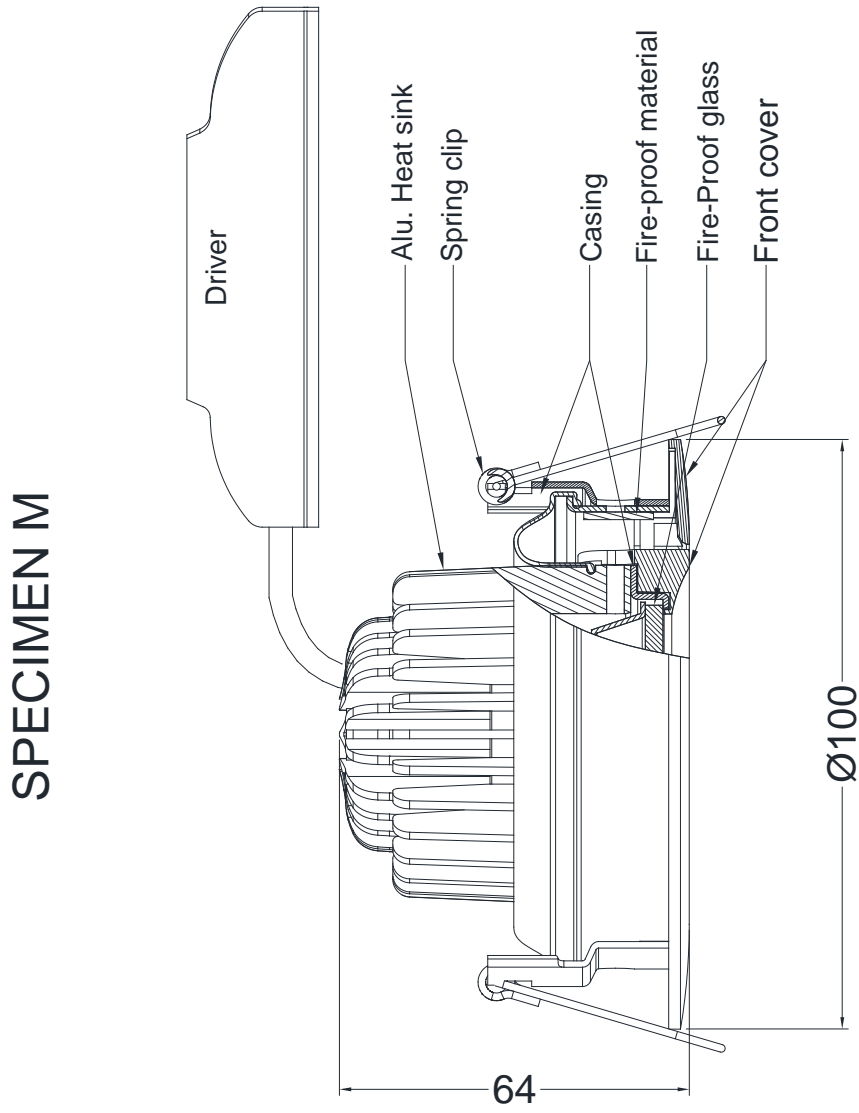
Figure 4 – Details of Downlighters Specimen M

SPECIMEN M

Tilttable
With reflector ILDLFR92CXXX
Cut out: Ø92

11. Specimen J	: Item reported separately
12. Specimen K	: Item reported separately
13. Specimen L	: Item reported separately
14. Specimen M	
Manufacturer	: Integral LED
Type	: Round, tiltable, LED recessed downlight
Reference	: ILDLFR92CXXX
Materials

i. casing	: Mild steel
ii. front cover	: Die cast aluminium
iii. heat sink	: Die cast aluminium
iv. spring clip	: Stainless steel
v. gasket	: 4.3 mm wide x 1.7 mm thick flexible plastics ring
Overall dimensions and construction	: See Figure 15 for details
Cut out size	: 92 mm diameter
Driver	: None
Lamp	: COB

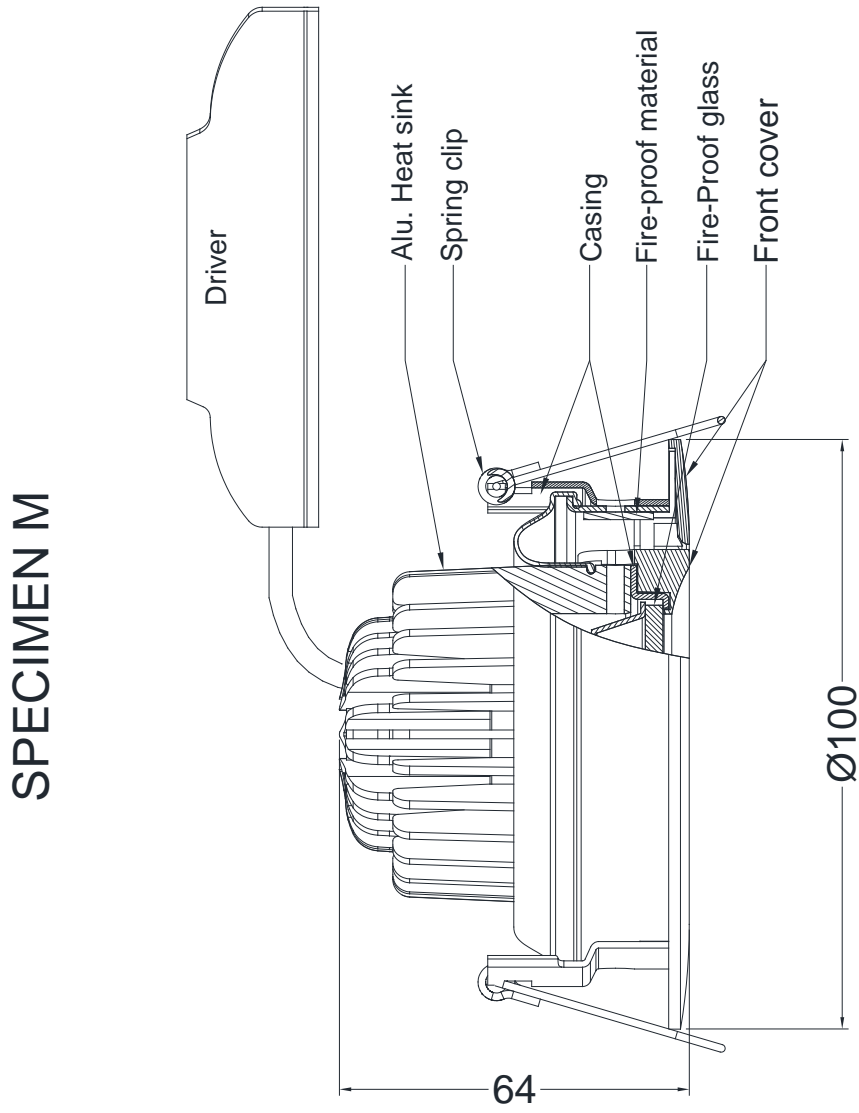
Figure 4 – Details of Downlighters Specimen M

SPECIMEN M

Tilttable
With reflector ILDLFR92CXXX
Cut out: Ø92

i. casing	: Mild steel
ii. front cover	: Die cast aluminium
iii. heat sink	: Die cast aluminium
iv. spring clip	: Stainless steel
v. gasket	: 4.3 mm wide x 1.7 mm thick flexible plastics ring
Overall dimensions and construction	: See Figure 15 for details
Cut out size	: 92 mm diameter
Driver	: None
Lamp	: COB

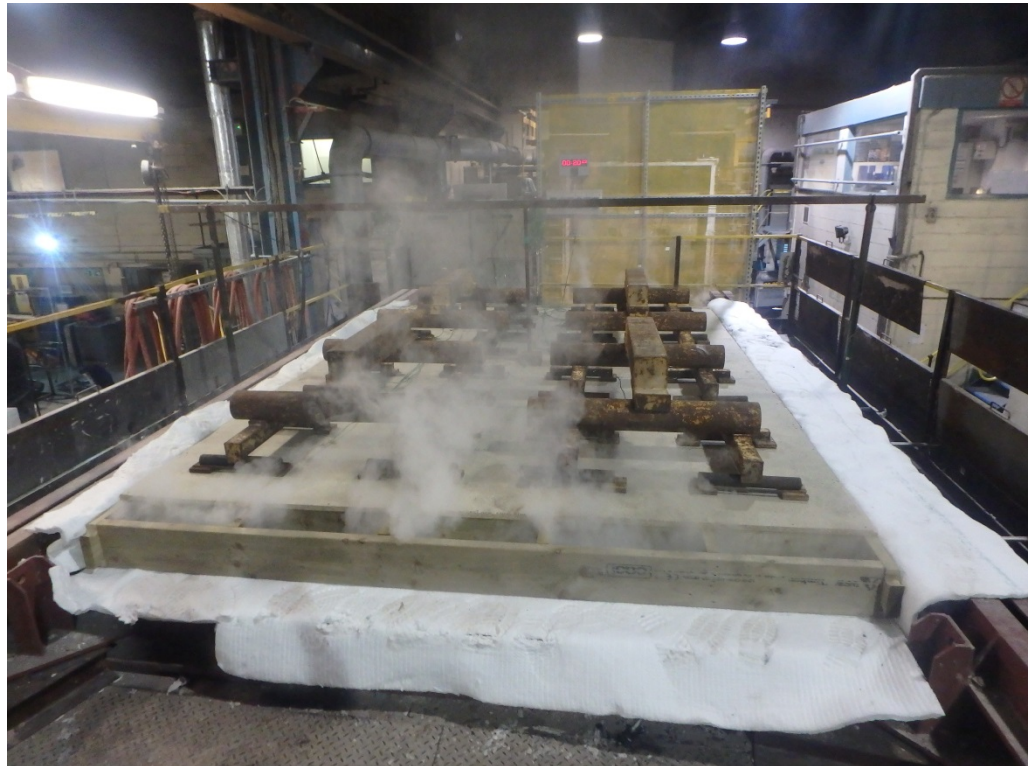
The unexposed face of the assembly after 20 minutes of testing

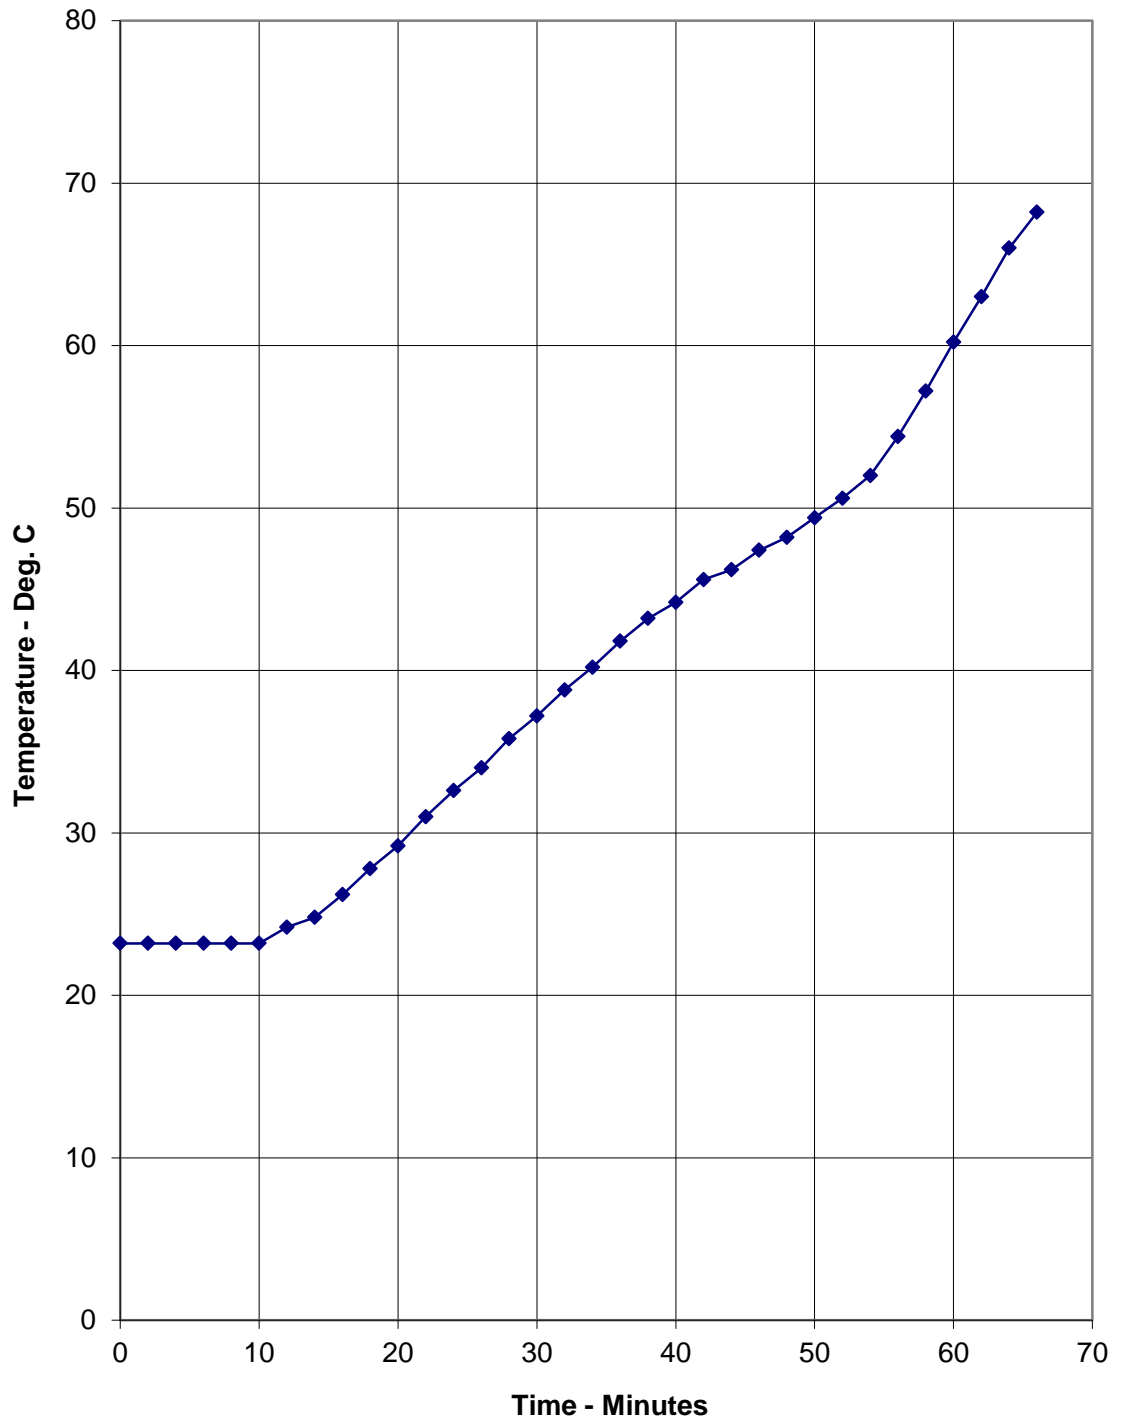
Graph showing mean unexposed surface temperature of the floor assembly

Insulation It is required that the mean temperature rise of the unexposed surface shall not be greater than 140°C and that the maximum temperature rise shall not be greater than 180°C. Insulation failure occurs simultaneously with integrity failure. The insulation requirements were satisfied for the 66 minute test duration.
